North East Mountain Trust

BALMORE TO AUCHTAVEN HILLTRACK REPORT

**Statement for
SCOTTISH GOVERNMENT Hearing
17th November, 2007**

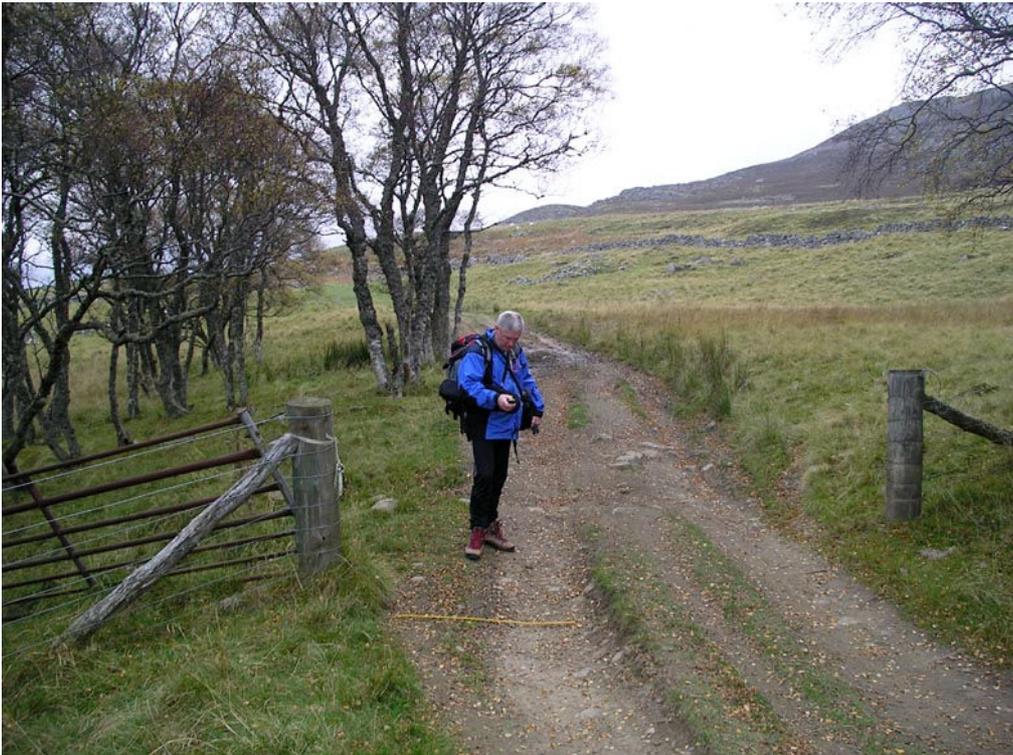
[Picture: 1238]

- a) SNH state within their Constructed tracks in the Scottish Uplands, 'Good Practice Guide' (2006) that the aim will normally be to minimise a tracks running width since this will help reduce the impact on surrounding habitats and earth heritage, interests and make it easier to fit in to the landscape. The wider the track the more substantial will be the earthworks required to negotiate steep slopes ect
- b) The original track had a width similar to that of the unaltered section on the approach to Auchtavan. See picture 1238 below;

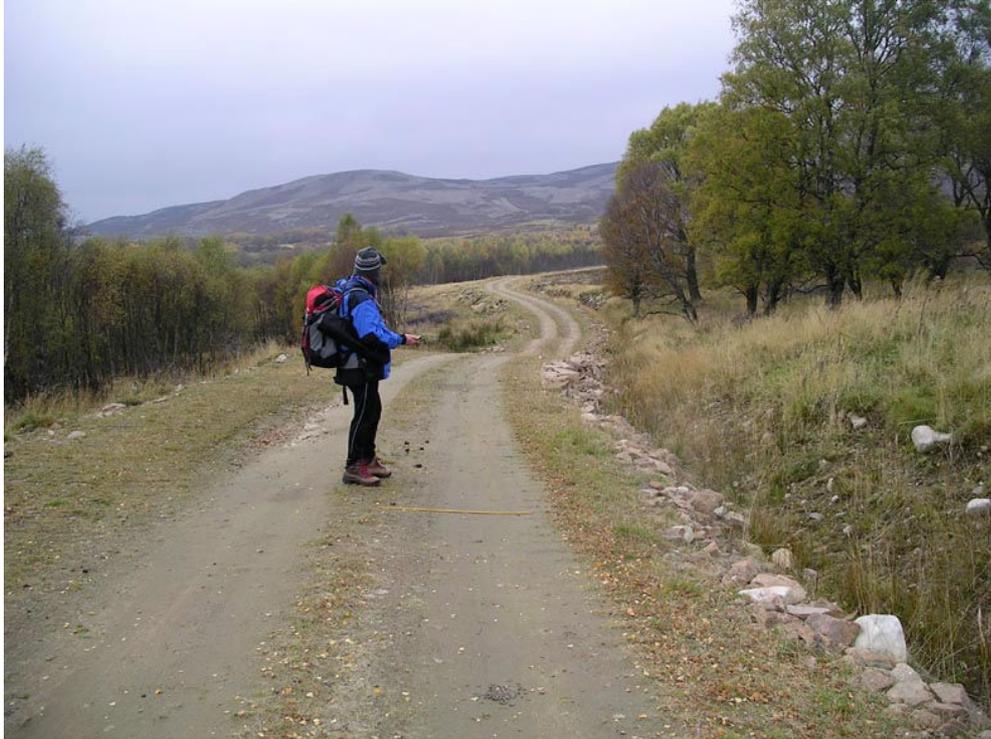
[Picture: 1224]

And the altered section of the track is now in some places double its original width (See picture 1224 below).

Had these works been carried out in a proper manner originally it would have been very easy to complete the work in a way which would have been more aesthetically pleasing visually and sympathetic to the landscape. However even at this stage it will in our view be possible to reinstate the ground to minimise the worst of the visual impact.

Reduced track width to a maximum of 3 meters wide and return it nearer to its original character. This can be achieved by filling in

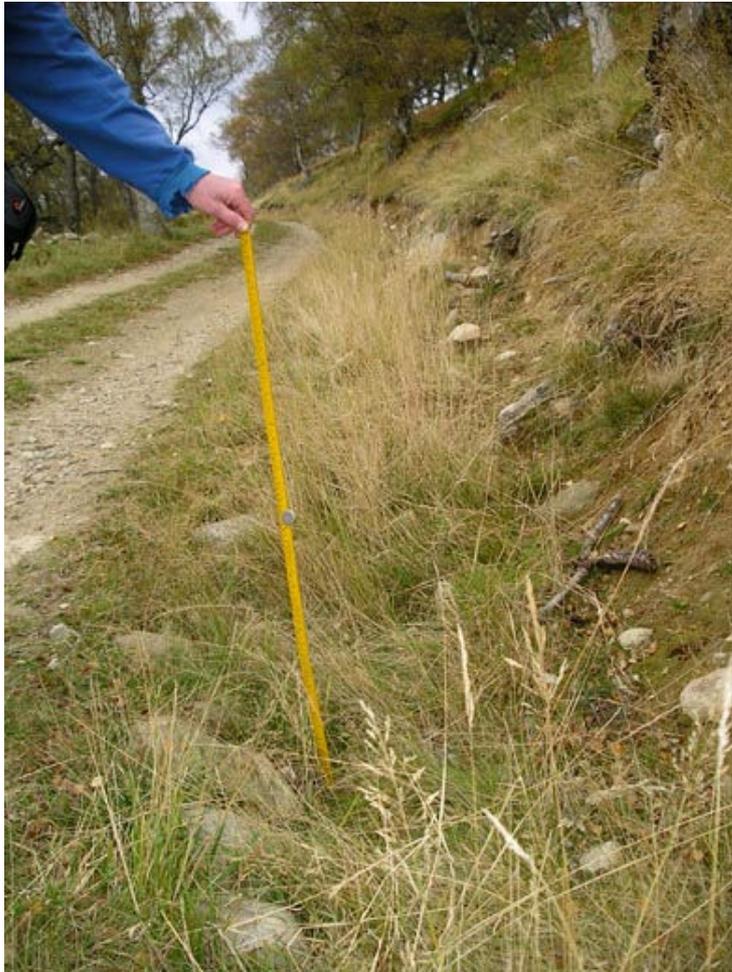
[Picture: 1196]

most of the drainage ditch on the uphill side of the track. At the moment this ditch is not providing drainage. Much of the ditch has already become blocked; with silt, rock and vegetation in many places. (See picture 1196)

Reduce the gradient of the steep uphill face of the drainage ditch to no more than 30 degrees to blend in with the gradients of the existing hillside.

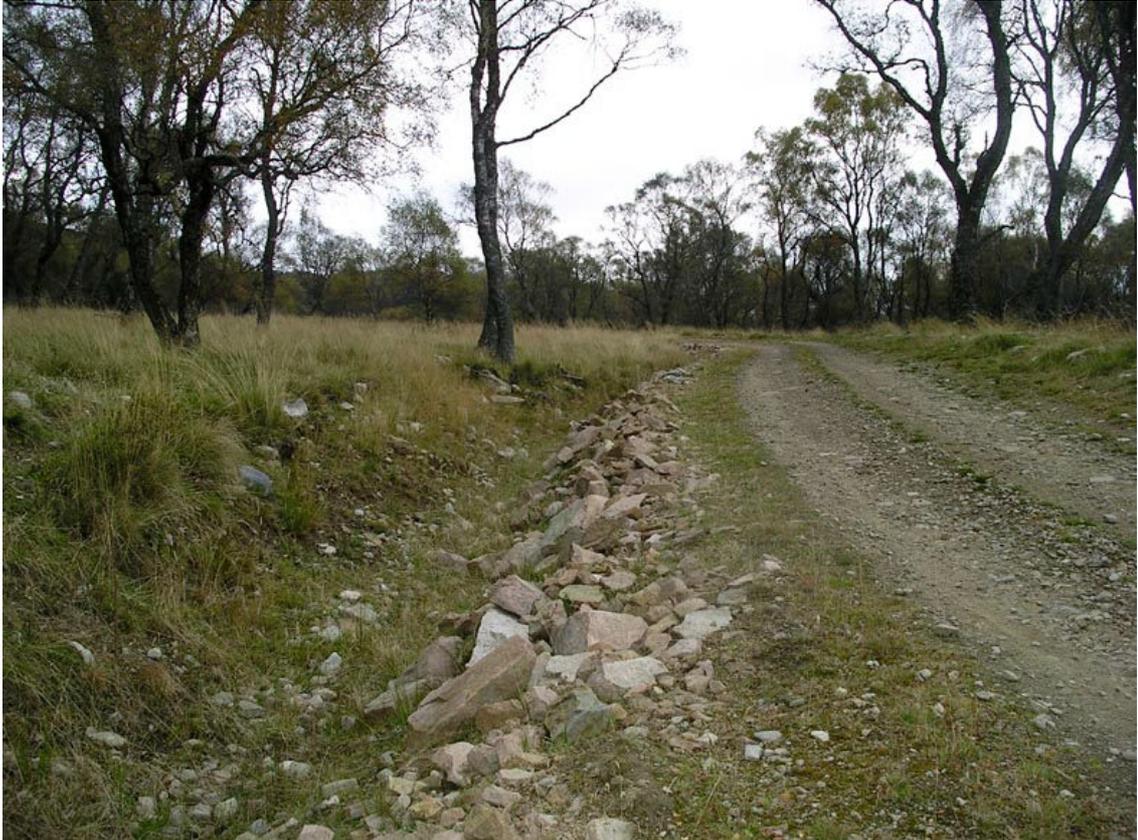
[Picture: 1220]

Bare rocks which currently are evident along the length of the track above the S bends some of this rock could potentially be

used to help fill in the drainage ditch and would act as a field drain. However they would then need to be covered over with top soil and turfs so they would be invisible (See picture 1220)

Any excess rocks which cannot be used in this way would require to be disposed of.

Improving visual impact by re-turfing and re-seeding where appropriate.

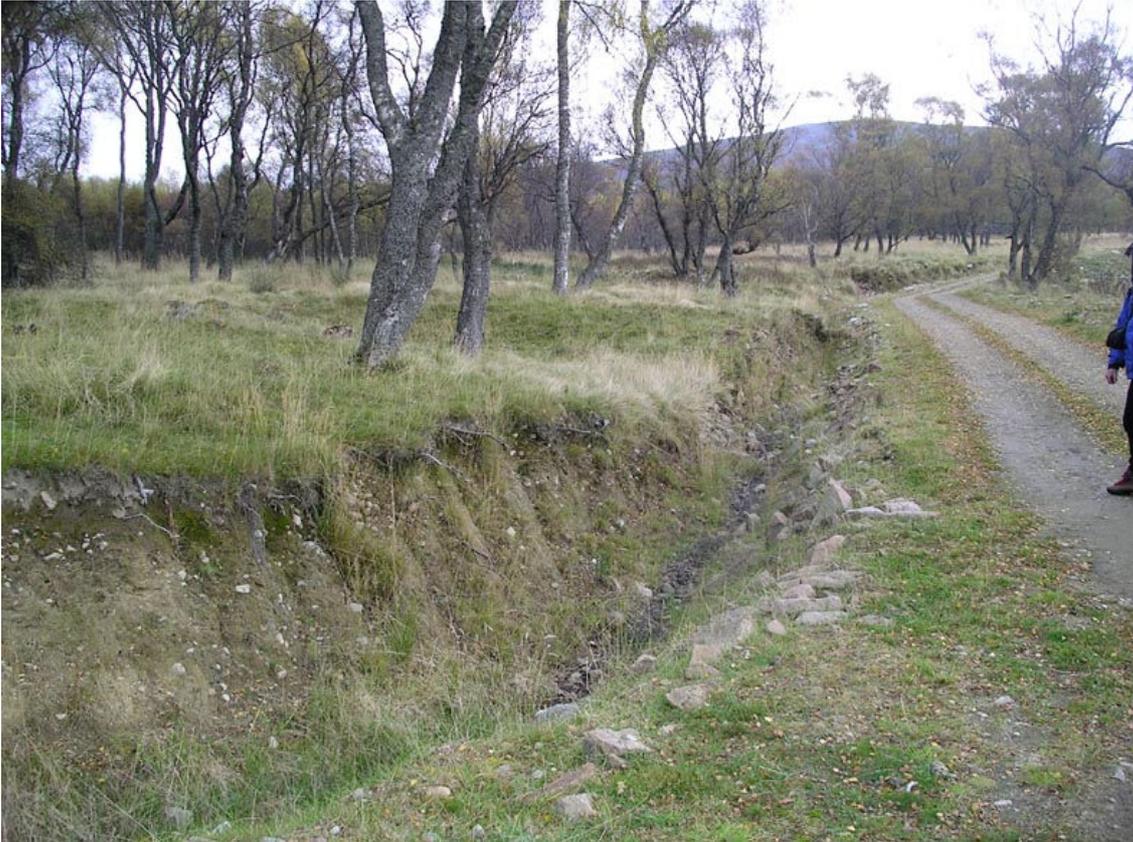
[Picture: 1219]

However a large drainage ditch has been dug unnecessarily deep along the whole length of the track on the upslope and on the flat section towards Auchtavan and has created in a number of places a near vertical exposed face of subsoil resulting in a significant visual impact on the landscape

Photo 1219 below highlights near vertical drainage ditch.

With the use of an excavator either carefully remove turfs and topsoil and where possible blend the slopes back into the natural profile of the hill, to a gradient of no more than thirty degrees or with addition of extra materials fill in and carefully cover the bare areas by returning existing topsoil and turfs to the re-graded slope along with the addition of some new vegetation i.e. turfing of heathers or artificial seeding with heather and /or grasses It may also be appropriate to include some new woodland planting in areas alongside the track that have been affected either directly or indirectly by the engineering works

By grading out these ditches it should be possible to blend them into the surrounding slopes, achieving more successful revegetation and reducing the risk of erosion. This will significantly improve the appearance of the track.

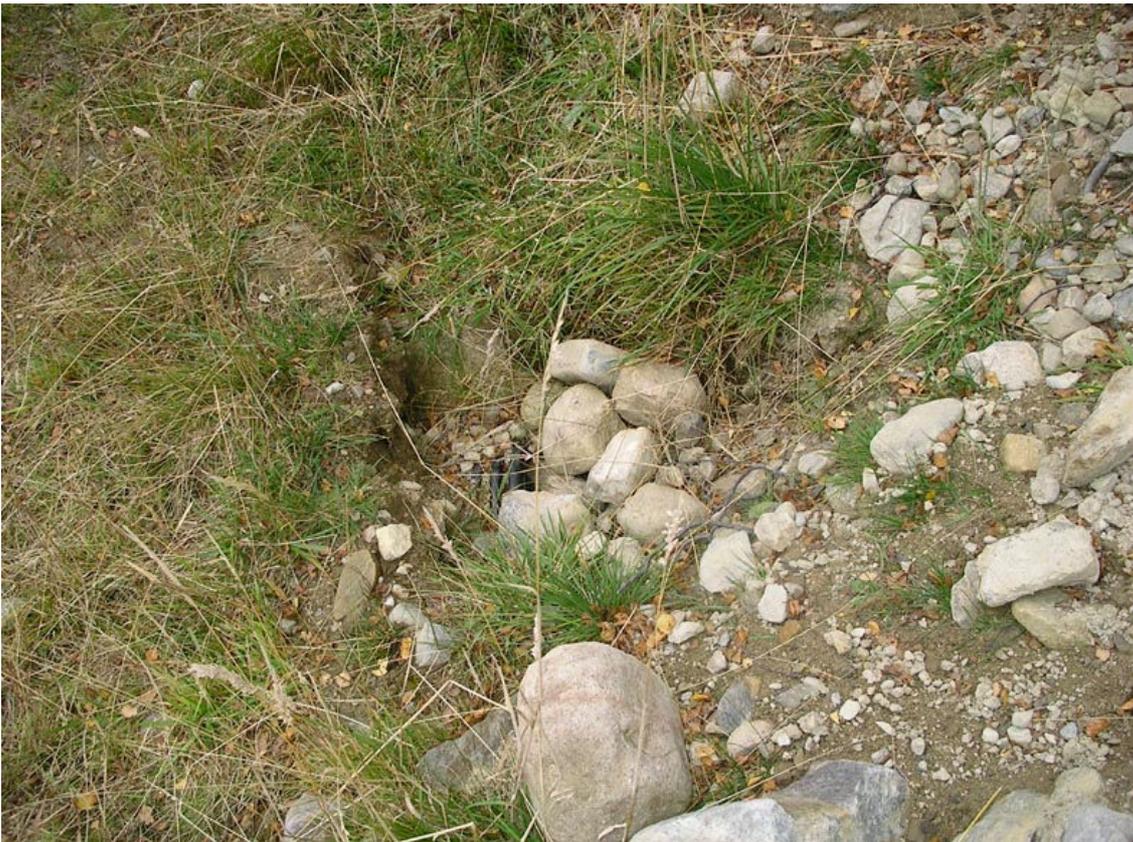
[Picture: 1204]

The majority of culverts currently in place are partially blocked with little evidence of them providing anything in the way of drainage despite this the downhill slopes do not appear to be adversely affected by this state of affairs. This provides further evidence that the vast majority of these culverts are simply not required. (See pictures 1204 – Showing the entrance to a blocked culvert within the drainage ditch, 1195).

With the removal of the large drainage ditches, the use of culverts should only be required at locations where streams or natural drainage channels cross the track. Optimum drainage could be achieved with a combination of culverts and cross drains. Surplus culvert pipes should then be removed. The remaining culverts should be carefully designed with use of field drains and silt traps at the top most side of the culvert pipe, this would allow the water to slow down and deposit suspended material within the trap. The exit should be carefully chosen to end in a downhill sloping natural gully and should also have a stone splash apron to dissipate the energy of the water and thus avoid erosion.

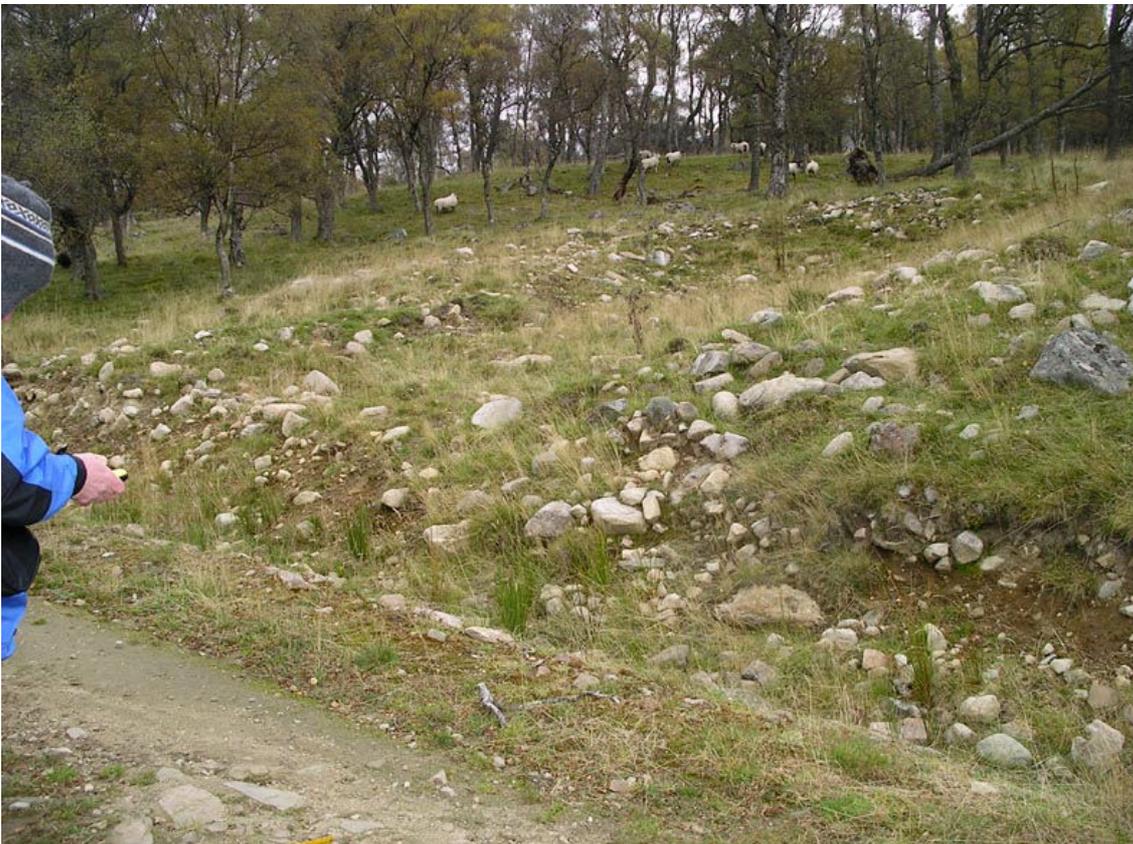
[Picture: 1216]

There is evidence of a large amount of bare rock left over from excavations strewn around the site which is unsightly and detracts from the natural beauty of the area. (See pictures 1216, 1236,)

This situation would be improved by gathering up all excess rock and fill in sump area created in borrow pit in picture 1236. Cover with soil then thin layer of peat or alternatively returf with heather and grasses.
